**Flood Control Project Maintenance  
Levee Inspections**  
**LMA District Cover Sheet**  
**Spring 2019 Levee Inspection Results**

**Reclamation District No. 0999 Netherlands**

**Spring 2019 Levee Inspection Results**

Waterway			Bank	Unit Miles
Unit No. 01 Yolo Bypass			Left	15.41
	Spring (March - May)	Summer (June - August)	(September - November) Fall	Winter (December - February)
Unit Maintenance Rating (Fall Only)				
Date of Inspection	3/21/2019 - 3/21/2019			
DWR Inspector	Luz Dial			
Accompanied By

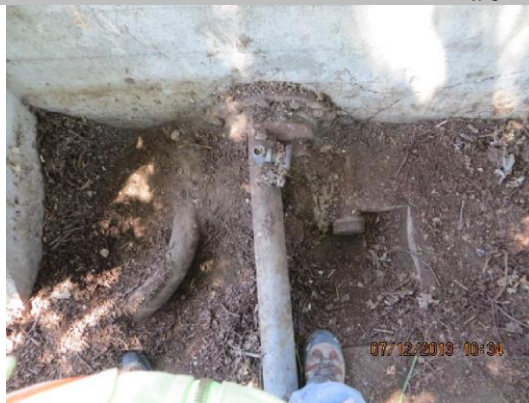
Photo 2 of 3 : UCIP\_SP\_2019\_15725\_26180.jpg

Siphon breaker at headwall on WS.

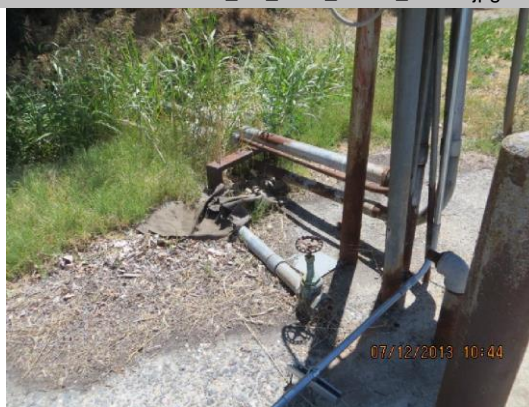
Photo 3 of 3 : UCIP\_SP\_2019\_15725\_26179.jpg

Pipe with gate valve off LS toe.

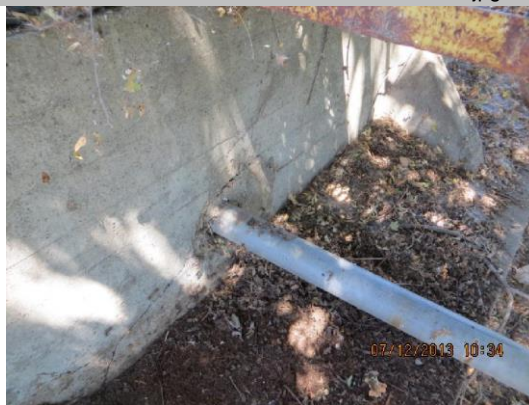
Photo 2 of 3 : UCIP\_SP\_2019\_41556\_26159.jpg

4.5-inch pipe at headwall on WS slope.

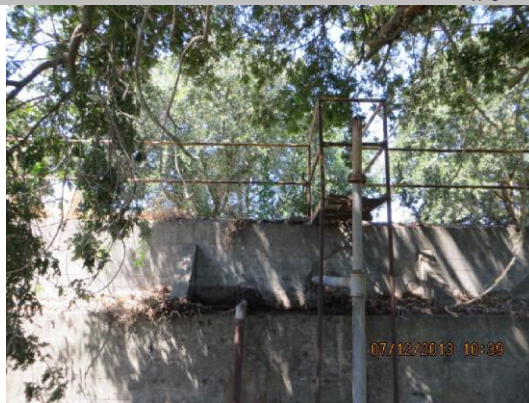
Photo 3 of 3 : UCIP\_SP\_2019\_41556\_26158.jpg

4.5-inch pipe at headwall on WS slope.

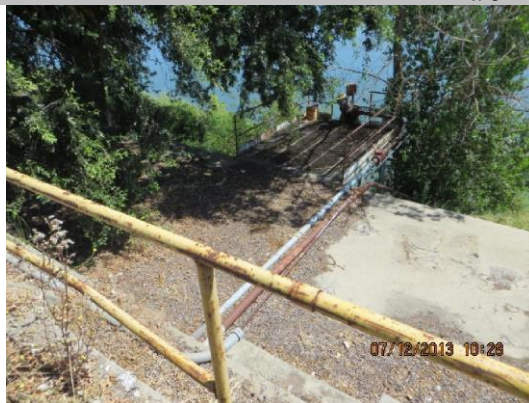
Photo 1 of 2 : UCIP\_SP\_2019\_41535\_26167.jpg

LM Start	0.74	Rating **	M	Issue No.	59
LM End	0.74	Issue Type +	En	Location *	
Category	Supplemental			GPS Latitude/Longitude	
				Start	End
Item	DWR UCIP Field Study			38.423418 °	38.423418 °
				-121.529486 °	-121.529486 °
DWR ID	22795				
Comment Code					
Inspector Comment					
FS_ID:41535 DS_ID:22795 EP_NO: N/A Repair Type: Non-Urgent Crossing Status: Found UCIP Comments: Pipes appear abandoned and should be checked usage or abandoned properly. FIELD_STRUCT_DESC: 3.5-inch galvanized iron electrical conduit through the levee, 3.8 feet below the crown. Concrete headwall and pad on the waterside (WS) slope. Pipe open on the WS. [Additional Reference(s): DWR Levee Log, 1992. USACE Sacramento O&M Manual 113 (revision), October 1966, (HLM 0.73), listed as two 10-inch pipes]. FS Date: 7/12/2013

Electrical conduit shown at bottom of picture (pipe with 90-degree bend).

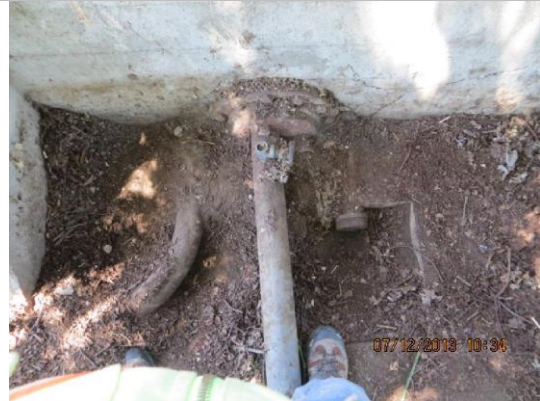
Photo 2 of 2 : UCIP\_SP\_2019\_41535\_26166.jpg

LM Start	0.74	Rating **	M	Issue No.	59 (cont)
LM End	0.74	Issue Type +	En	Location *	
Category	Supplemental			GPS Latitude/Longitude	
				Start	End
Item	DWR UCIP Field Study			38.423418 °	38.423418 °
				-121.529486 °	-121.529486 °
DWR ID	22795				
Comment Code					
Inspector Comment					
FS_ID:41535 DS_ID:22795 EP_NO: N/A Repair Type: Non-Urgent Crossing Status: Found UCIP Comments: Pipes appear abandoned and should be checked usage or abandoned properly. FIELD_STRUCT_DESC: 3.5-inch galvanized iron electrical conduit through the levee, 3.8 feet below the crown. Concrete headwall and pad on the waterside (WS) slope. Pipe open on the WS. [Additional Reference(s): DWR Levee Log, 1992. USACE Sacramento O&M Manual 113 (revision), October 1966, (HLM 0.73), listed as two 10-inch pipes]. FS Date: 7/12/2013

3.5-inch electrical conduit shown at left of 10-inch pipe.

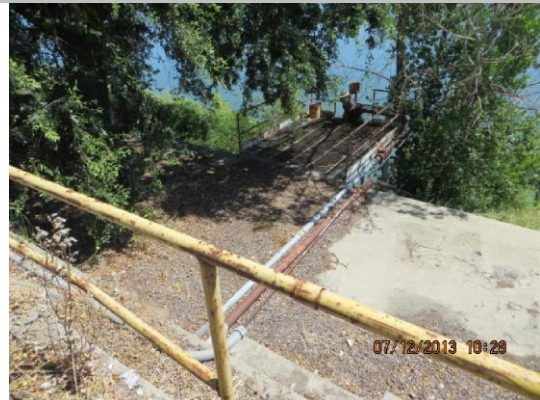
Photo 1 of 3 : UCIP\_SP\_2019\_41070\_26174.jpg

LM Start	0.74	Rating **	M	Issue No.	60
LM End	0.74	Issue Type +	En	Location *	
Category	Supplemental			GPS Latitude/Longitude	
				Start	End
Item	DWR UCIP Field Study			38.423429 °	38.423429 °
				-121.529491 °	-121.529491 °
DWR ID	22811				
Comment Code					
Inspector Comment					
FS_ID:41070 DS_ID:22811 EP_NO: 10514 Repair Type: Non-Urgent Crossing Status: Found UCIP Comments: Need to determine disposition of pipe and if abandoned, it should be done so properly. FIELD_STRUCT_DESC: 2 of 3: 4.5-inch galvanized iron irrigation pipe through the levee, 3 feet below the crown. Slant pump, steel walkway, and steel vent pipe on the waterside (WS) slope. Shutoff valve off the landside (LS) toe. (Permit No. 10514, 1975 - The Newhall Land and Farming Company). [Additional Reference(s): DWR Levee Log, 1992]. FS Date: 7/12/2013

Pipe and slant pump on WS at concrete pad.

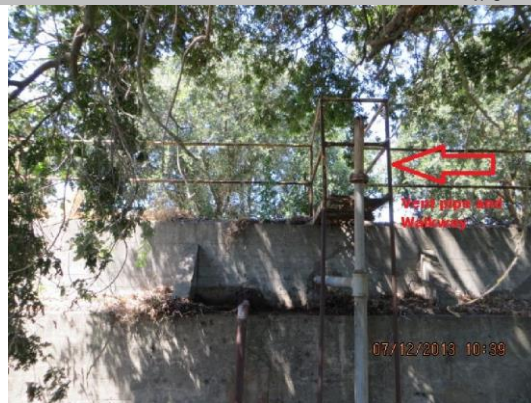
Photo 2 of 3 : UCIP\_SP\_2019\_41070\_26173.jpg

Pipe, walkway, and vent on WS shoulder.

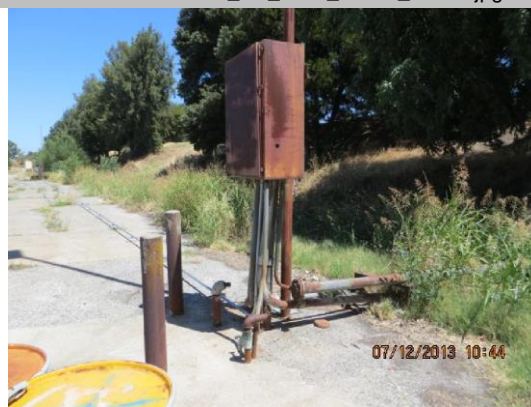
Photo 3 of 3 : UCIP\_SP\_2019\_41070\_26175.jpg

Pipe with cap or gate valve on end off LS toe.

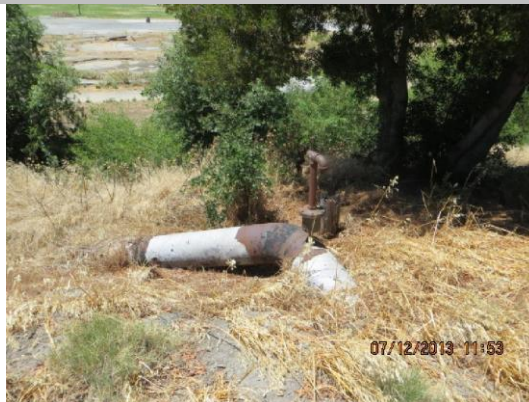
Photo 2 of 2 : UCIP\_SP\_2019\_16389\_27668.jpg

Pipe and vent/siphon breaker on LS slope.

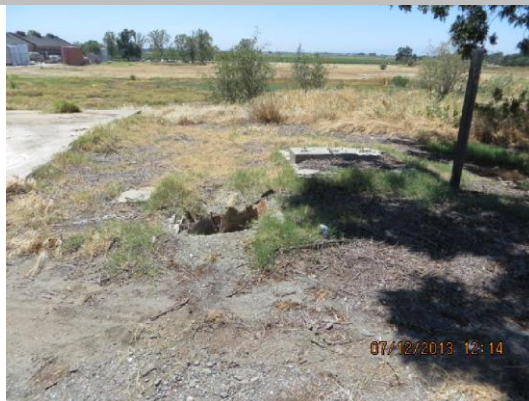
Photo 2 of 3 : UCIP\_SP\_2019\_16385\_27654.jpg

Pipe in concrete vault on LS shoulder.

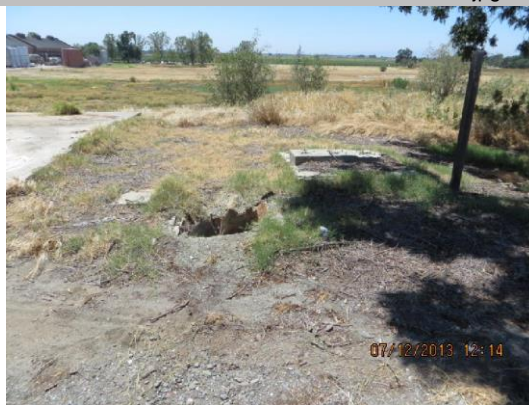
Photo 2 of 3 : UCIP\_SP\_2019\_15728\_26188.jpg

Pipes visible in concrete well on LS shoulder.

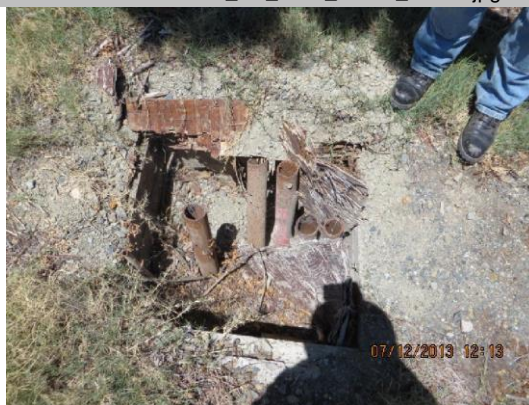
Photo 1 of 3 : UCIP\_SP\_2019\_15733\_26197.jpg

LM Start	0.91	Rating **	M	Issue No.	67
LM End	0.91	Issue Type +	En	Location *	
Category	Supplemental			GPS Latitude/Longitude	
				Start	End
Item	DWR UCIP Field Study			38.425514 °	38.425514 °
				-121.530970 °	-121.530970 °
DWR ID	22808				
Comment Code					
Inspector Comment					
FS_ID:15733 DS_ID:22808 EP_NO: N/A Repair Type: Non-Urgent Crossing Status: Found UCIP Comments: Pipe abandoned and should be done so properly. FIELD_STRUCT_DESC: *ABANDONED* 4 of 6: 3.5-inch pipe of an unknown material or purpose through the levee, 2.5 feet below the crown. Pipe visible in concrete wells on the landside (LS) and the waterside (WS) shoulders. [Additional Reference(s): DWR Levee Log, 1992]. FS Date: 7/12/2013

Pipe in concrete well on LS shoulder.

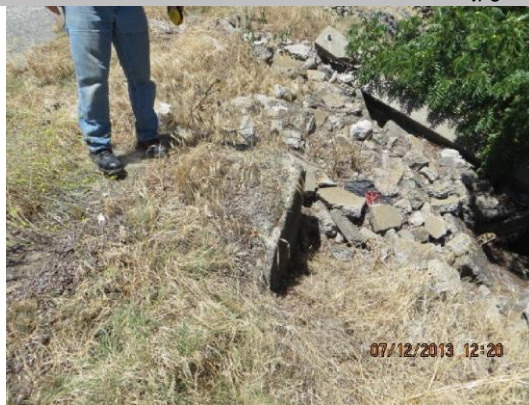
Photo 3 of 3 : UCIP\_SP\_2019\_15733\_26195.jpg

Pipe assumed visible in concrete well on WS shoulder.

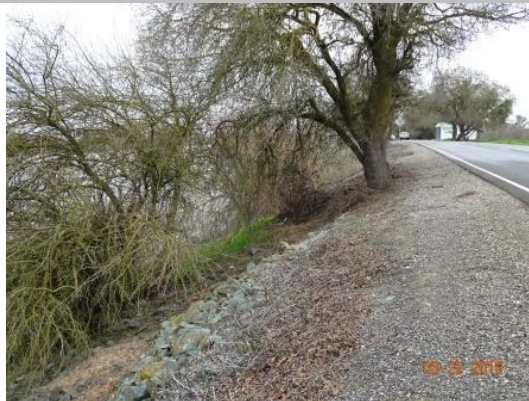
Photo 1 of 1 : SP\_2019\_RD0999\_235\_25\_20190405\_00069.jpg

LM Start	0.96	Rating **	M	Issue No.	25
LM End	0.99	Issue Type +	Ma	Location *	WS
Category	Earthen Levee			GPS Latitude/Longitude	
				Start	End
Item	Trim / Thin Trees			38.426310 °	38.426627 °
				-121.531460 °	-121.531577 °
DWR ID	DWR_RD0999_04_s_2019_25				
Comment Code					
T1 : Trim trees to at least five feet above ground level.					
Inspector Comment

View looking downstream of low-hanging tree branches on levee slope. Spring 2019

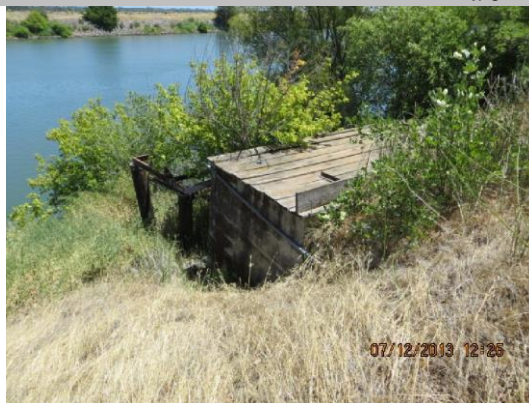
Photo 1 of 3 : UCIP\_SP\_2019\_16387\_27664.jpg

Comment Code						
Inspector Comment						
FS_ID:16387						
DS_ID:22800						
EP_NO: N/A						
Repair Type: Non-Urgent						
Crossing Status: Found						
UCIP Comments: Pipe appears abandoned and should be done so properly.						
FIELD_STRUCT_DESC: 24-inch steel irrigation pipe through the levee, 13 feet below the crown. Pipe measures 16 inches in diameter on the waterside (WS) and 24 inches in diameter on the landside (LS) toe. Gate valve in a 9-foot by 18-foot concrete well on the WS slope. Slant pump missing from the WS slope. Concrete distribution house/box at the LS toe. 1.5-inch galvanized iron electrical conduit at the same location. [Additional Reference(s): DWR Levee Log, 1992. USACE Sacramento O&M Manual 113 (Revised), October 1966, (HLM 0.99)].						
FS Date: 7/12/2013

Slide gate in 9'X18' concrete box on WS slope.

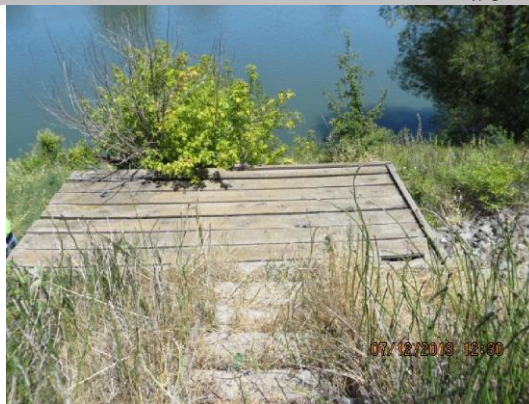
Photo 3 of 3 : UCIP\_SP\_2019\_16387\_27662.jpg

Comment Code						
Inspector Comment						
FS_ID:16387 DS_ID:22800 EP_NO: N/A Repair Type: Non-Urgent Crossing Status: Found UCIP Comments: Pipe appears abandoned and should be done so properly. FIELD_STRUCT_DESC: 24-inch steel irrigation pipe through the levee, 13 feet below the crown. Pipe measures 16 inches in diameter on the waterside (WS) and 24 inches in diameter on the landside (LS) toe. Gate valve in a 9-foot by 18-foot concrete well on the WS slope. Slant pump missing from the WS slope. Concrete distribution house/box at the LS toe. 1.5-inch galvanized iron electrical conduit at the same location. [Additional Reference(s): DWR Levee Log, 1992. USACE Sacramento O&M Manual 113 (Revised), October 1966, (HLM 0.99)]. FS Date: 7/12/2013

9'X18' concrete box with gatevalve on WS slope.

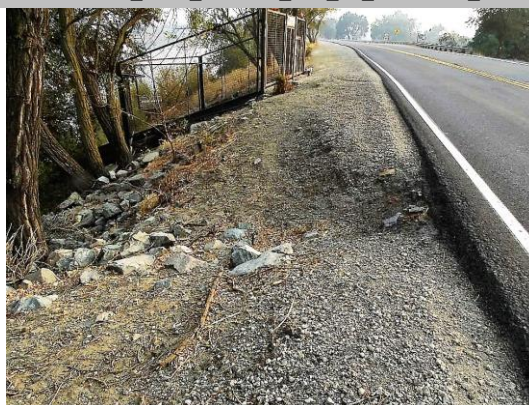
Photo 1 of 3 : SP\_2019\_RD0999\_235\_46\_20190307\_00020.jpg

LM Start	1.18	Rating **	M	Issue No.	46
LM End	1.18	Issue Type +	Ma	Location *	WS
Category	Earthen Levee			GPS Latitude/Longitude	
				Start	End
Item	Erosion / Bank Caving			38.429201 °	38.429201 °
				-121.533012 °	-121.533012 °
DWR ID	DWR_RD0999_04_s_2016_46				
Comment Code					
E2 : Schedule repair of erosion site prior to the next inspection.					
Inspector Comment					
Erosion located just below asphalt on waterside shoulder.

View of erosion on shoulder and slope. Fall 2018

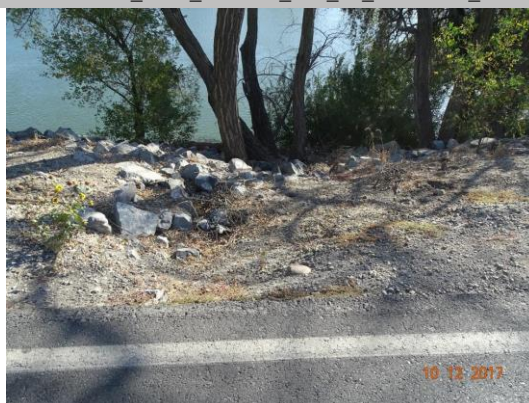
Photo 2 of 3 : SP\_2019\_RD0999\_235\_46\_20190307\_00021.jpg

Looking east at the erosion on the waterside slope. Fall 2017

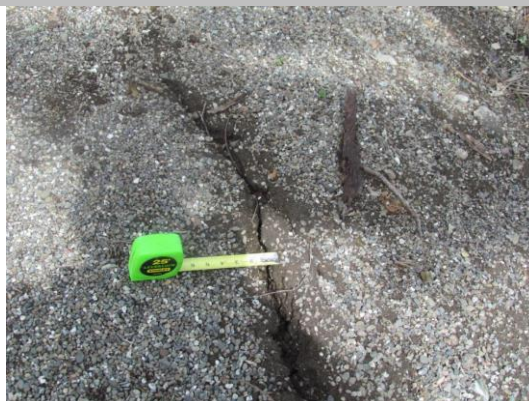
Photo 1 of 3 : SP\_2019\_RD0999\_236\_165\_20190307\_00070.jpg

LM Start	0.11	Rating **	M	Issue No.	165
LM End	0.12	Issue Type +	Ma	Location *	WS
Category	Earthen Levee			GPS Latitude/Longitude	
				Start	End
Item	Slope Stability			38.334198 °	38.334327 °
				-121.584308 °	-121.584275 °
DWR ID	DWR_RD0999_05_s_2017_165				
Comment Code					
S1 : Repair slope instability.					
Inspector Comment					
Crack greater than two inches along top half of waterward slope. Three dead trees along slope damage section. Trees should be removed.

Looking at two inch plus crack on waterward shoulder.

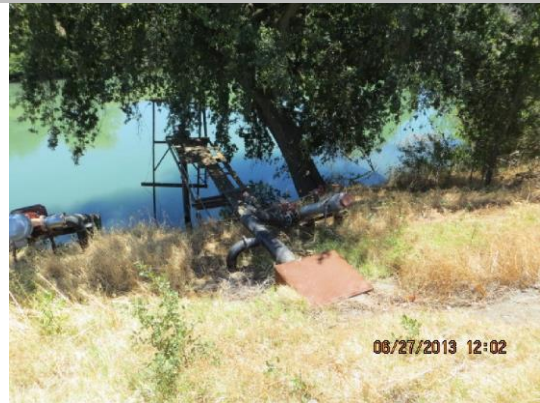
Photo 1 of 3 : UCIP\_SP\_2019\_15411\_25295.jpg

Comment Code					
Inspector Comment					
FS_ID:15411 DS_ID:22839 EP_NO: N/A Repair Type: Non-Urgent Crossing Status: Found UCIP Comments: Walkway to pump on pier is falling appart and should be removed. FIELD_STRUCT_DESC: 12-inch steel irrigation pipe through the levee, 11 feet below the crown. 10-inch pipe visible on slopes and at slant pump on the waterside (WS) slope. Pump on structure removed. Additional slant pump on the WS slope ties into pipe. 30-inch steel standpipe on the landside (LS) toe. Butterfly valves located on both sides of the levee. 3-foot by 3-foot steel junction box on the WS shoulder, and a 31-inch by 60-inch steel junction box on the LS shoulder. Service poles on both slopes. [Additional Reference(s): DWR Levee Log, 1992. USACE Sacramento O&M Manual 113 (Revised), October 1966, (HLM 0.23)]. FS Date: 6/27/2013

Pump and steel junction box visible on WS slope.

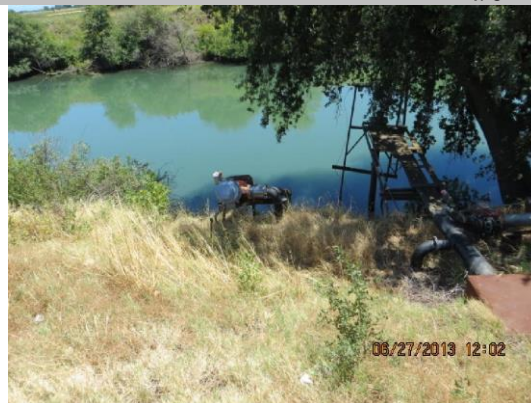
Photo 2 of 3 : UCIP\_SP\_2019\_15411\_25294.jpg

2nd Pump visible on WS slope.

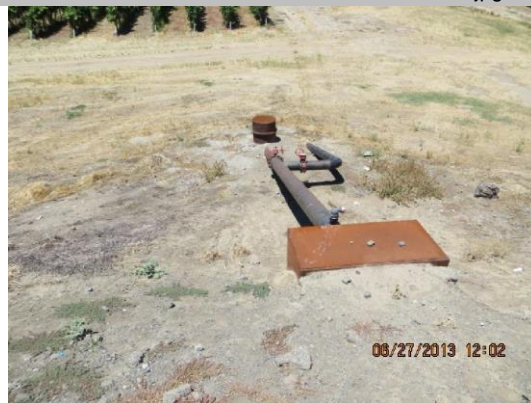
Photo 3 of 3 : UCIP\_SP\_2019\_15411\_25293.jpg

Steel junction box, vent, butterfly valve, and standpipe visible on LS slope.

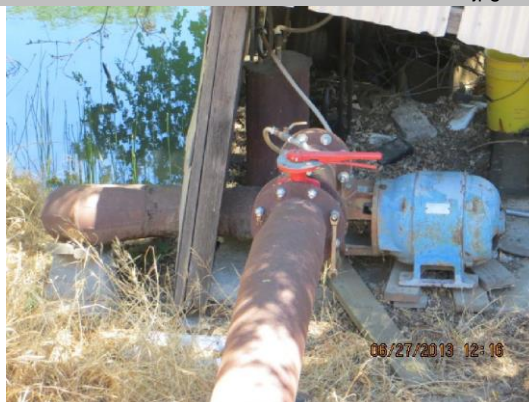
Photo 2 of 3 : UCIP\_SP\_2019\_15413\_25303.jpg

Butterfly valve at pumphouse on WS slope.

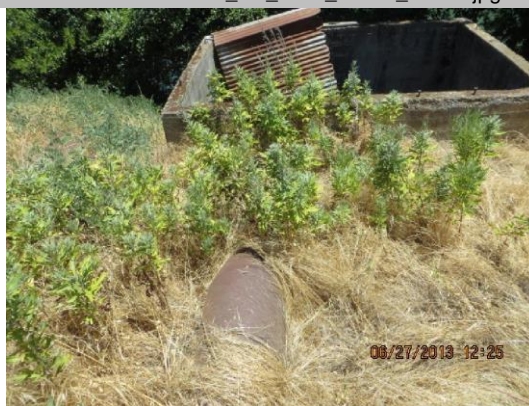
Photo 2 of 3 : UCIP\_SP\_2019\_15414\_25307.jpg

LM Start	0.58	Rating **	M	Issue No.	230 (cont)	
LM End	0.58	Issue Type +	En	Location *		
Category	Supplemental			GPS Latitude/Longitude		
				Start	End	
Item	DWR UCIP Field Study			38.340651 °	38.340651 °	
				-121.581861 °	-121.581861 °	
DWR ID	22841					
Comment Code						
Inspector Comment						
FS_ID:15414						
DS_ID:22841						
EP_NO: N/A						
Repair Type: Non-Urgent						
Crossing Status: Found						
UCIP Comments: Pipe abandoned and should be done so properly.						
FIELD_STRUCT_DESC: *ABANDONED* 16-inch steel irrigation pipe						
through the levee, 6 feet below the crown. Concrete pump house on the						
waterside (WS) slope. [Additional Reference(s): DWR Levee Log, 1992.						
USACE Sacramento O&M Manual 113 (revision), October 1966, (HLM						
0.61)].						
FS Date: 6/27/2013

Pipe visible on WS slope.

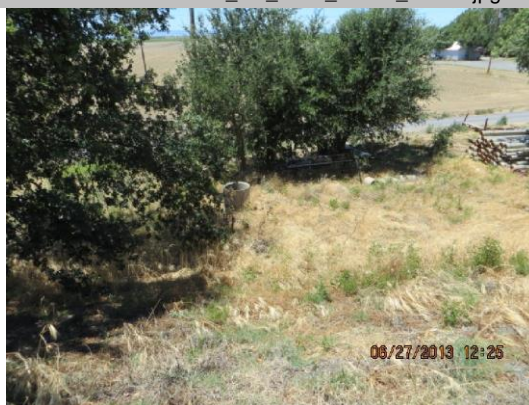
Photo 3 of 3 : UCIP\_SP\_2019\_15414\_25306.jpg

Pipe may be aligned with concrete standpipe at LS toe, but no pipe is visible on LS.

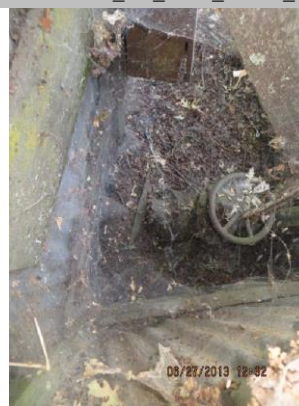
Photo 2 of 2 : UCIP\_SP\_2019\_15450\_25385.jpg

Pipe rusted through at gatevalve inside pumphouse.

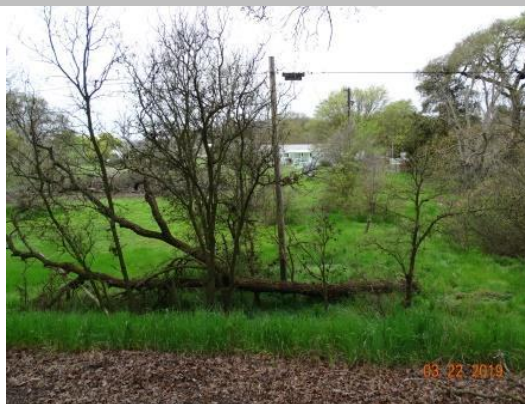
Photo 1 of 1 : SP\_2019\_RD0999\_236\_52\_20190328\_00172.jpg

LM Start	0.76	Rating **	M	Issue No.	52
LM End	0.76	Issue Type +	En	Location *	LS
Category	Earthen Levee			GPS Latitude/Longitude	
				Start	End
Item	Encroachments			38.343253 °	38.343253 °
				-121.581318 °	-121.581318 °
DWR ID	DWR_RD0999_05_s_2019_52				
Comment Code					
TR : Tree or limb					
Inspector Comment					
Landowner needs to remove fallen tree from levee easement.

View looking west at fallen tree within levee easement. Spring 2019

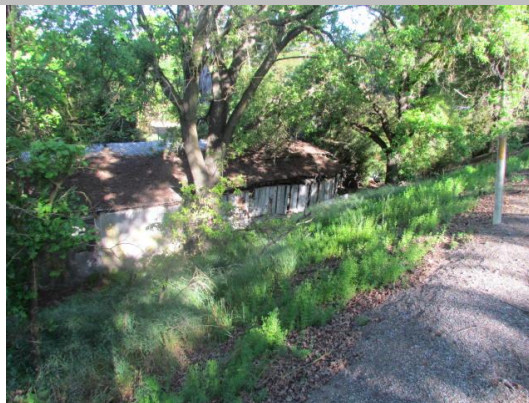
Photo 1 of 2 : SP\_2019\_RD0999\_236\_23\_20190307\_00015.jpg

LM Start	0.77	Rating **	U	Issue No.	23
LM End	0.77	Issue Type +	En	Location *	LS
Category	Earthen Levee			GPS Latitude/Longitude	
				Start	End
Item	Encroachments			38.343358 °	38.343358 °
				-121.581295 °	-121.581295 °
DWR ID	DWR_RD0999_05_f_2012_23				
Comment Code					
BU : Building					
Inspector Comment					
Storage shed at landside toe does not have a permit.

Looking northwest at abandoned storage shed at landward toe. (Spring 2015)

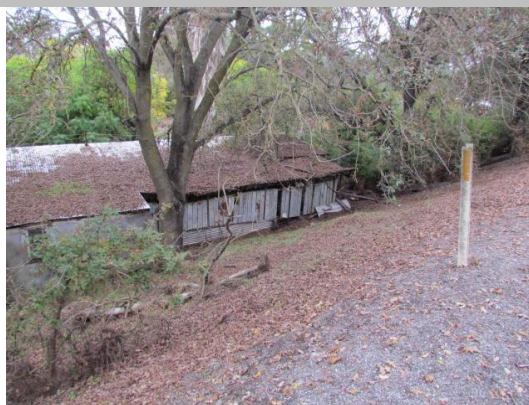
Photo 2 of 2 : SP\_2019\_RD0999\_236\_23\_20190307\_00016.jpg

Looking northwest at storage shed at landside toe and within the 10' easement.

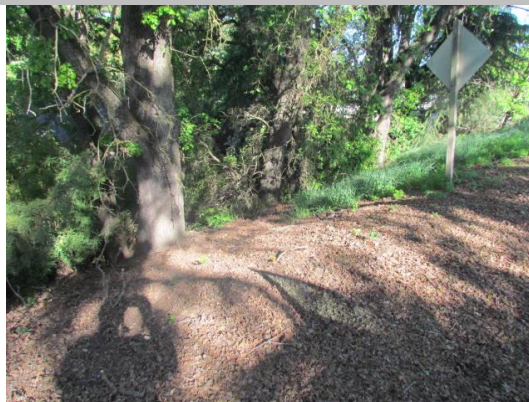
Photo 1 of 2 : SP\_2019\_RD0999\_236\_128\_20190307\_00053.jpg

LM Start	0.78	Rating **	M	Issue No.	128
LM End	0.79	Issue Type +	Ma	Location *	LS
Category	Earthen Levee			GPS Latitude/Longitude	
				Start	End
Item	Trim / Thin Trees			38.343495 °	38.343617 °
				-121.581282 °	-121.581249 °
DWR ID	DWR_RD0999_05_s_2012_128				
Comment Code					
T3 : Trim and thin trees to allow visibility of the ground and room to flood fight.					
Inspector Comment

Looking northwest at untrimmed trees on landward slope. (Spring 2015)

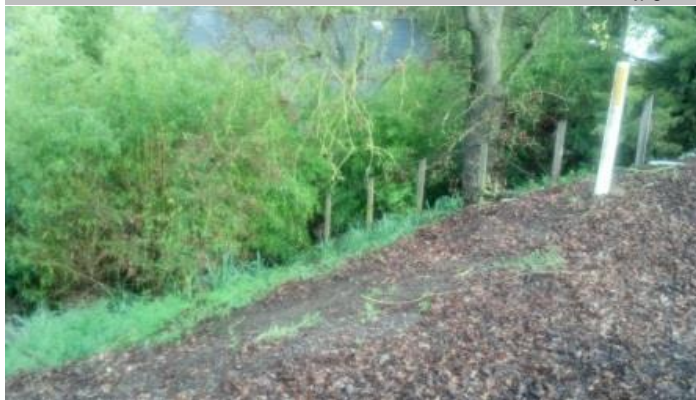
Photo 2 of 2 : SP\_2019\_RD0999\_236\_128\_20190307\_00054.jpg

Looking at dense trees on landside slope and toe.

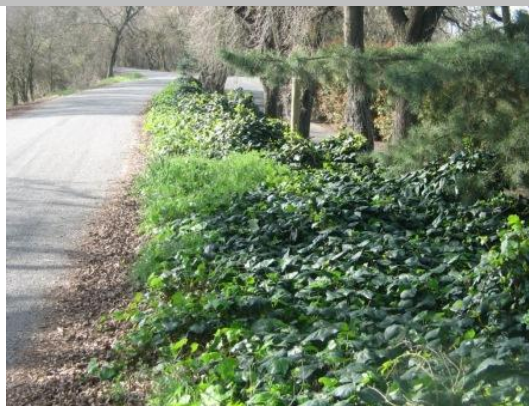
Photo 1 of 2 : SP\_2019\_RD0999\_236\_11\_20190307\_00006.jpg

LM Start	0.80	Rating **	U	Issue No.	11
LM End	0.90	Issue Type +	En	Location *	LS
Category	Earthen Levee			GPS Latitude/Longitude	
				Start	End
Item	Vegetation			38.343825 °	38.345215 °
				-121.581133 °	-121.580728 °
DWR ID	DWR_RD0999_05_s_2012_11				
Comment Code					
V6 : Landscaping					
Inspector Comment

View of landscaping (Ivy) looking upstream.

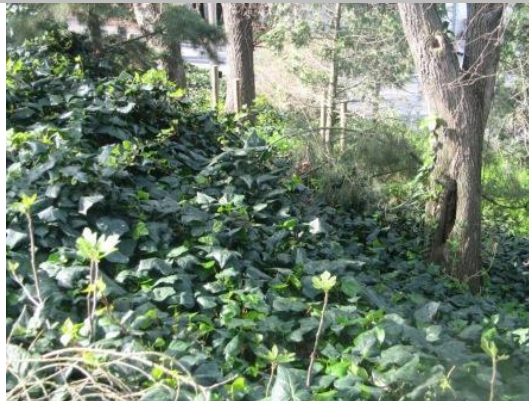
Photo 2 of 2 : SP\_2019\_RD0999\_236\_11\_20190307\_00007.jpg

LM Start	<b>0.80</b>	Rating **	U	Issue No.	<b>11 (cont)</b>
LM End	<b>0.90</b>	Issue Type +	En	Location *	LS

View of landscaping (Ivy) blocking view of landside slope.

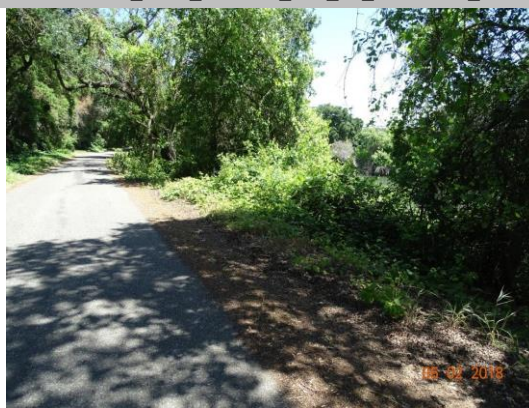
Photo 1 of 1 : SP\_2019\_RD0999\_236\_10\_20190307\_00005.jpg

LM Start	0.84	Rating **	M	Issue No.	10
LM End	0.84	Issue Type +	Ma	Location *	WS
Category	Earthen Levee			GPS Latitude/Longitude	
				Start	End
Item	Vegetation			38.344294 °	38.344294 °
				-121.581054 °	-121.581054 °
DWR ID	DWR_RD0999_05_s_2018_10				
Comment Code					
V2 : Remove the wild growth other than native grasses from the levee slopes.					
Inspector Comment					
LMA sprayed vegetation but needs to clear dead vegetation.

Vegetation waterside looking north. Spring 2018

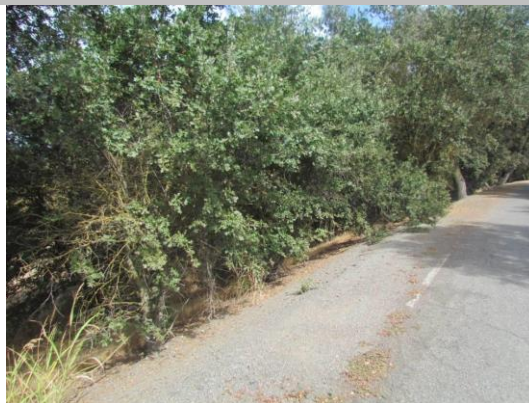
Photo 1 of 1 : SP\_2019\_RD0999\_236\_14\_20190307\_00010.jpg

LM Start	1.07	Rating **	M	Issue No.	14
LM End	1.11	Issue Type +	En	Location *	LS
Category	Earthen Levee			GPS Latitude/Longitude	
				Start	End
Item	Vegetation			38.347427 °	38.347863 °
				-121.579395 °	-121.579113 °
DWR ID	DWR_RD0999_05_s_2012_14				
Comment Code					
V6 : Landscaping					
Inspector Comment					
Instruct landowner to trim and thin trees on levee easement.

Looking west at untrimmed trees on landward slope and toe.

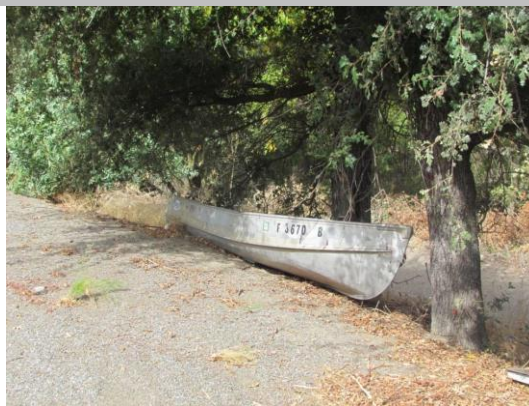
Photo 1 of 1 : SP\_2019\_RD0999\_236\_169\_20190307\_00076.jpg

LM Start	1.18	Rating **	M	Issue No.	169
LM End	1.18	Issue Type +	En	Location *	LS
Category	Earthen Levee			GPS Latitude/Longitude	
				Start	End
Item	Encroachments			38.348339 °	38.348339 °
				-121.577840 °	-121.577840 °
DWR ID	DWR_RD0999_05_f_2016_169				
Comment Code					
EQ : Equipment					
Inspector Comment					
Instruct landowner to move boat off of landside easement.

Looking southwest at boat on landward slope.

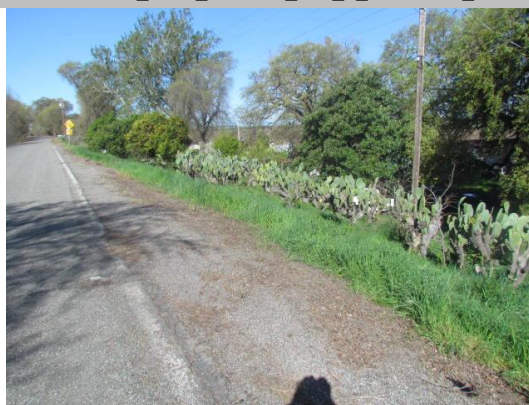
Photo 1 of 4 : SP\_2019\_RD0999\_236\_2\_20190307\_00001.jpg

LM Start	1.28	Rating **	U	Issue No.	2
LM End	1.28	Issue Type +	En	Location *	LS
Category	Earthen Levee			GPS Latitude/Longitude	
				Start	End
Item	Vegetation			38.348279 °	38.348279 °
				-121.576061 °	-121.576061 °
DWR ID	DWR_RD0999_05_s_2012_2				
Comment Code					
V6 : Landscaping					
Inspector Comment					
Instruct landowner to remove landscaping from landside slope.

Looking southwest at dense cactus plants on landward slope and toe.

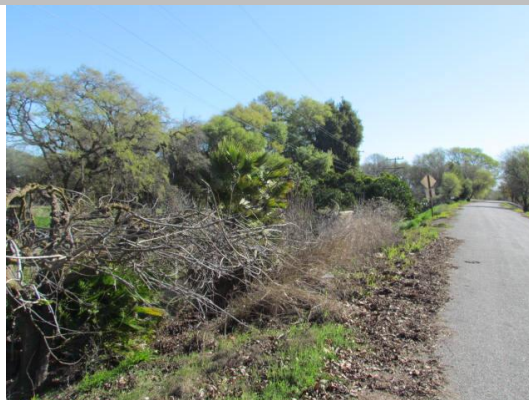
Photo 2 of 4 : SP\_2019\_RD0999\_236\_2\_20190307\_00002.jpg

LM Start	<b>1.28</b>	Rating **	U	Issue No.	<b>2 (cont)</b>
LM End	<b>1.28</b>	Issue Type +	En	Location *	LS

Looking south at landscaping on landward slope.

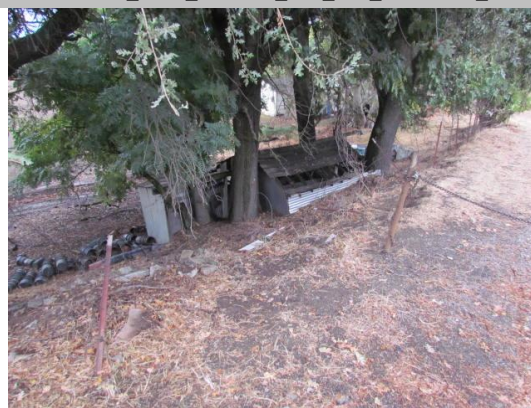
Photo 1 of 3 : SP\_2019\_RD0999\_236\_172\_20190307\_00079.jpg

LM Start	1.31	Rating **	U	Issue No.	172
LM End	1.31	Issue Type +	En	Location *	LS
Category	Earthen Levee			GPS Latitude/Longitude	
				Start	End
Item	Encroachments			38.348248 °	38.348248 °
				-121.575467 °	-121.575467 °
DWR ID	DWR_RD0999_05_f_2015_172				
Comment Code					
BU : Building					
Inspector Comment					
Toolshed located at landside toe is unauthorized.

Looking southwest at toolshed at landward toe.

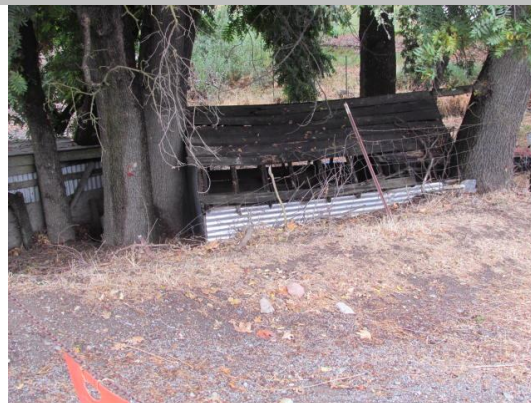
Photo 2 of 3 : SP\_2019\_RD0999\_236\_172\_20190307\_00080.jpg

LM Start	<b>1.31</b>	Rating **	U	Issue No.	<b>172 (cont)</b>
LM End	<b>1.31</b>	Issue Type +	En	Location *	LS

Looking west at toolshed at landward toe.

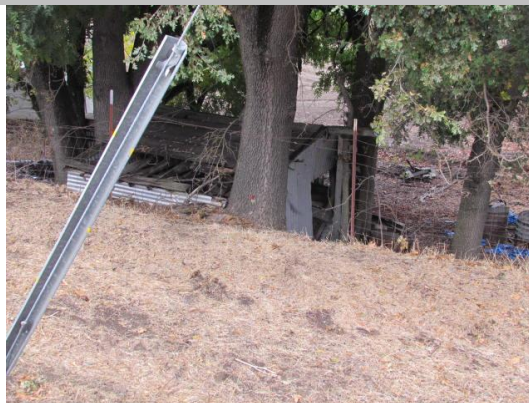
Photo 3 of 3 : SP\_2019\_RD0999\_236\_172\_20190307\_00081.jpg

LM Start	1.31	Rating **	U	Issue No.	172 (cont)	
LM End	1.31	Issue Type +	En	Location *	LS	
Category	Earthen Levee			GPS Latitude/Longitude		
				Start		End
Item	Encroachments			38.348248 °		38.348248 °
				-121.575467 °		-121.575467 °
DWR ID	DWR_RD0999_05_f_2015_172					
Comment Code						
BU : Building						
Inspector Comment						
Toolshed located at landside toe is unauthorized.

Looking at northwest at toolshed at landward toe.

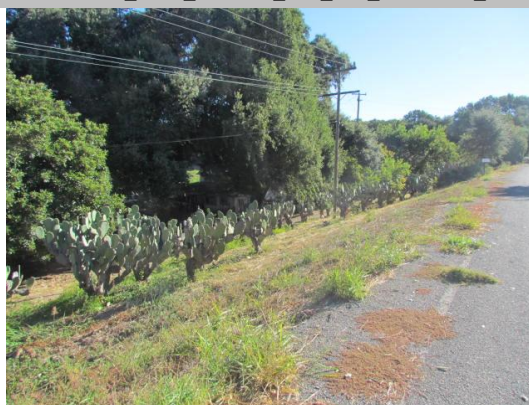
Photo 1 of 1 : SP\_2019\_RD0999\_236\_149\_20190307\_00060.jpg

LM Start	1.33	Rating **	M	Issue No.	149
LM End	1.36	Issue Type +	En	Location *	LS
Category	Earthen Levee			GPS Latitude/Longitude	
				Start	End
Item	Vegetation			38.348223 °	38.348191 °
				-121.575223 °	-121.574667 °
DWR ID	DWR_RD0999_05_f_2013_149				
Comment Code					
V6 : Landscaping					
Inspector Comment					
Instruct landowner to remove large cactus plants on landside slope.

Looking northwest at several cactus plants on landward slope.

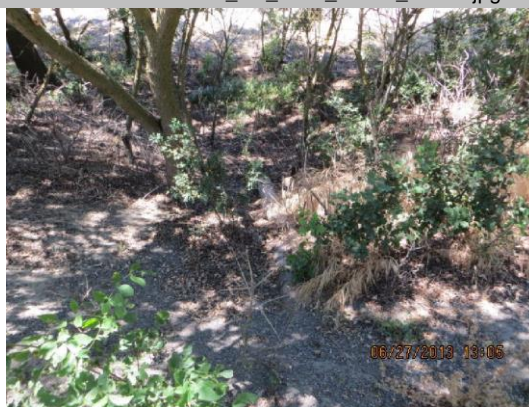
Photo 2 of 2 : UCIP\_SP\_2019\_15421\_25322.jpg

LM Start	<b>1.83</b>	Rating **	M	Issue No.	<b>233 (cont)</b>
LM End	<b>1.83</b>	Issue Type +	En	Location *

Pipe visible on LS slope.

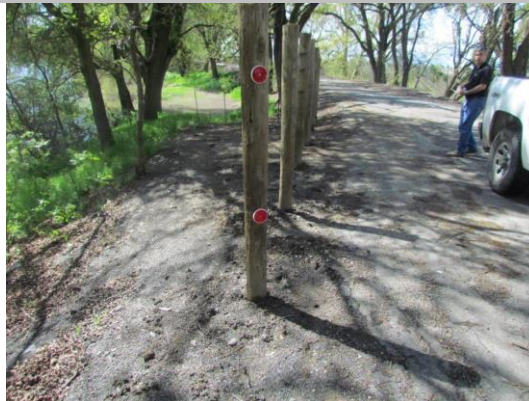
Photo 1 of 3 : SP\_2019\_RD0999\_236\_167\_20190307\_00073.jpg

LM Start	2.00	Rating **	A/W	Issue No.	167
LM End	2.00	Issue Type +	En	Location *	WS
Category	Earthen Levee			GPS Latitude/Longitude	
				Start	End
Item	Encroachments			38.355538 °	38.355538 °
				-121.571398 °	-121.571398 °
DWR ID	DWR_RD0999_05_s_2017_167				
Comment Code					
PO : Pole					
Inspector Comment					
Remove poles 30 to 36 inches deep on waterside shoulder.

Looking downstream at wooden poles on waterward shoulder.

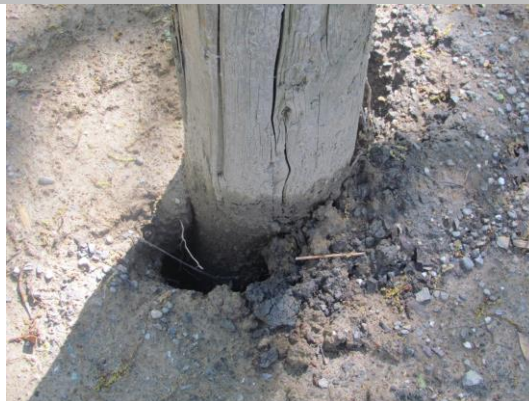
Photo 3 of 3 : SP\_2019\_RD0999\_236\_167\_20190307\_00075.jpg

LM Start	<b>2.00</b>	Rating **	A/W	Issue No.	<b>167 (cont)</b>
LM End	<b>2.00</b>	Issue Type +	En	Location *	WS

Looking at 3-4 ft hole for pole on waterward shoulder.

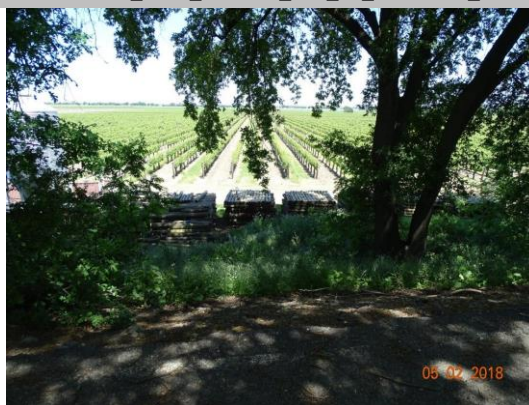
Photo 1 of 1 : SP\_2019\_RD0999\_236\_67\_20190307\_00028.jpg

LM Start	2.05	Rating **	M	Issue No.	67
LM End	2.05	Issue Type +	En	Location *	LS
Category	Earthen Levee			GPS Latitude/Longitude	
				Start	End
Item	Encroachments			38.355637 °	38.355637 °
				-121.570442 °	-121.570442 °
DWR ID	DWR_RD0999_05_s_2018_67				
Comment Code					
EQ : Equipment					
Inspector Comment					
Instruct landowner to move poles off of landside toe easement.

Encroachment poles landside looking northwest. Spring 2018

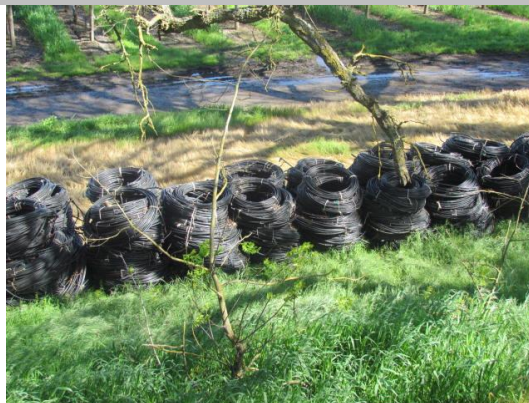
Photo 1 of 1 : SP\_2019\_RD0999\_236\_212\_20190307\_00095.jpg

LM Start	2.09	Rating **	M	Issue No.	212
LM End	2.09	Issue Type +	En	Location *	LS
Category	Earthen Levee			GPS Latitude/Longitude	
				Start	End
Item	Encroachments			38.355673 °	38.355673 °
				-121.569794 °	-121.569794 °
DWR ID	DWR_RD0999_05_s_2016_212				
Comment Code					
EQ : Equipment					
Inspector Comment					
Instruct farmer to move black sprinkler lines off of landside toe easement.

Looking south at black sprinkler lines at landward toe.

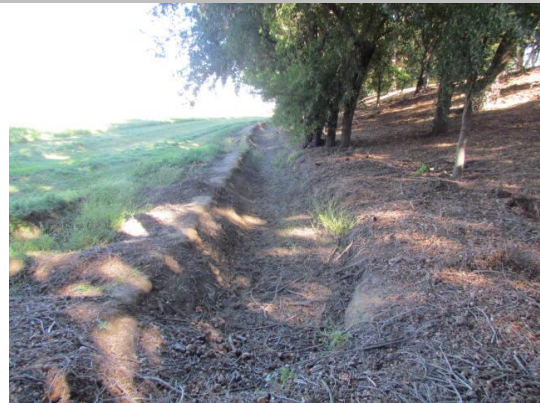
Photo 1 of 1 : SP\_2019\_RD0999\_236\_152\_20190307\_00061.jpg

LM Start	2.86	Rating **	M	Issue No.	152
LM End	3.12	Issue Type +	En	Location *	LS
Category	Earthen Levee			GPS Latitude/Longitude	
				Start	End
Item	Encroachments			38.361047 °	38.364409 °
				-121.563113 °	-121.561941 °
DWR ID	DWR_RD0999_05_f_2013_152				
Comment Code					
DT : Ditch					
Inspector Comment					
Irrigation ditch is unauthorized.

Looking north at abandoned irrigation ditch at landward toe.

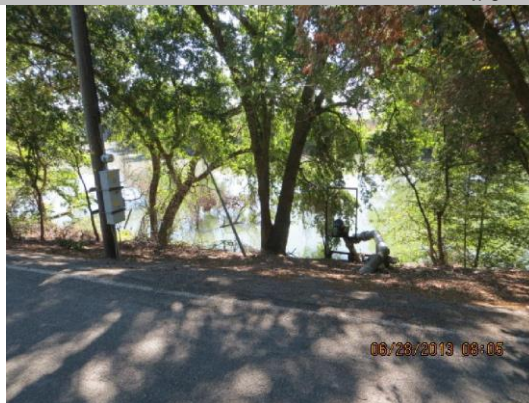
Photo 1 of 3 : UCIP\_SP\_2019\_53370\_25332.jpg

Comment Code						
Inspector Comment						
FS_ID:53370 DS_ID:22849 EP_NO: 7378 Repair Type: Non-Urgent Crossing Status: Found UCIP Comments: 07/26/2018 Pump was in operation at time of inspection and no leaks were detected. Erosion on LS toe same as last inspection, so no signs of erosion progression. Recommend monitoring this crossing; downgrading to Non-Urgent from Urgent (D. Sanoski - DWR UCIP).07/07/2016 - LS toe of levee still has erosion around stand pipe and adjacent oak tree. Erosion does not appear to be any worse than during previous inspection. no water in canal on LS toe led to the discovery of two additional appurtenant structures. (T. Hatch/UCIP)06/28/2013 - Pipe outlet is eroding the LS slope of the levee, exposing the roots of an oak and threatening greater damage if allowed to continue. (W. Wylie/UCIP) FIELD_STRUCT_DESC: 10-inch steel irrigation pipe through the levee, 6 feet below the crown. Slant pump and service pole on the waterside (WS) slope. 36-inch concrete standpipe on the landside (LS) toe. (Permit No. 7378, 1971 - Rudolph H. Volz. Replaced an existing 8-inch pipe at the same location). [Additional Reference(s): DWR Levee Log, 1992]. FS Date: 7/26/2018 10:26:00 AM

Slant pump, JP, and meter on WS slope.

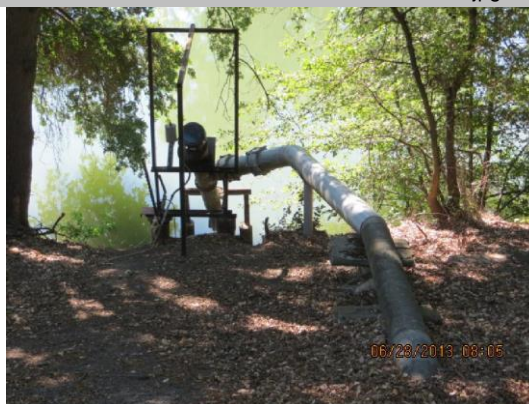
Photo 2 of 3 : UCIP\_SP\_2019\_53370\_25331.jpg

Slant pump and pipe on WS slope.

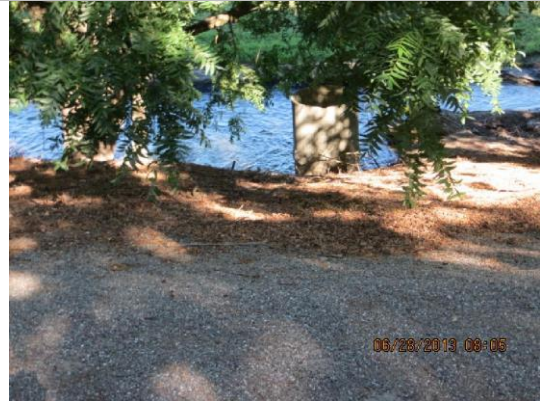
Photo 3 of 3 : UCIP\_SP\_2019\_53370\_25330.jpg

Comment Code						
Inspector Comment						
FS_ID:53370 DS_ID:22849 EP_NO: 7378 Repair Type: Non-Urgent Crossing Status: Found UCIP Comments: 07/26/2018 Pump was in operation at time of inspection and no leaks were detected. Erosion on LS toe same as last inspection, so no signs of erosion progression. Recommend monitoring this crossing; downgrading to Non-Urgent from Urgent (D. Sanoski - DWR UCIP).07/07/2016 - LS toe of levee still has erosion around stand pipe and adjacent oak tree. Erosion does not appear to be any worse than during previous inspection. no water in canal on LS toe led to the discovery of two additional appurtenant structures. (T. Hatch/UCIP)06/28/2013 - Pipe outlet is eroding the LS slope of the levee, exposing the roots of an oak and threatening greater damage if allowed to continue. (W. Wylie/UCIP) FIELD_STRUCT_DESC: 10-inch steel irrigation pipe through the levee, 6 feet below the crown. Slant pump and service pole on the waterside (WS) slope. 36-inch concrete standpipe on the landside (LS) toe. (Permit No. 7378, 1971 - Rudolph H. Volz. Replaced an existing 8-inch pipe at the same location). [Additional Reference(s): DWR Levee Log, 1992]. FS Date: 7/26/2018 10:26:00 AM

36-inch concrete standpipe on LS toe.

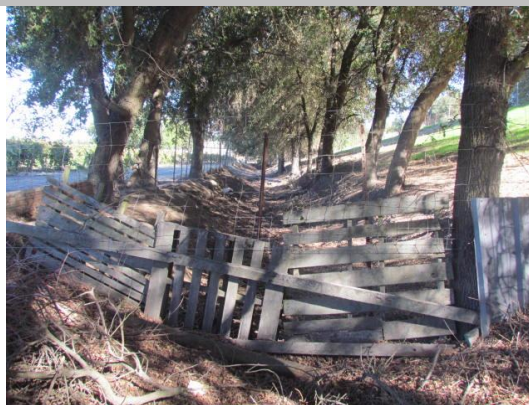
Photo 3 of 3 : SP\_2019\_RD0999\_236\_153\_20190307\_00064.jpg

Looking north at irrigation ditch at landward toe.

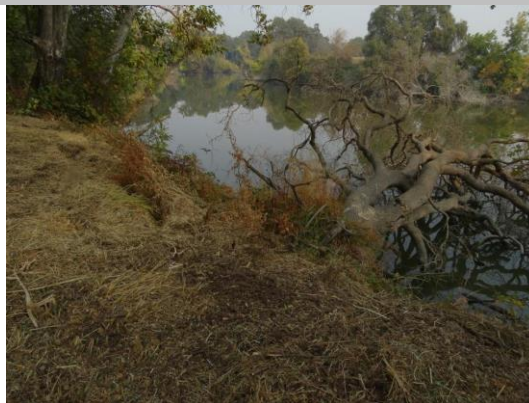
Photo 1 of 1 : SP\_2019\_RD0999\_236\_83\_20190307\_00034.jpg

LM Start	3.55	Rating **	M	Issue No.	83
LM End	3.55	Issue Type +	Ma	Location *	WS
Category	Earthen Levee			GPS Latitude/Longitude	
				Start	End
Item	Erosion / Bank Caving			38.365742 °	38.365742 °
				-121.556778 °	-121.556778 °
DWR ID	DWR_RD0999_05_f_2018_83				
Comment Code					
E1 : Note and monitor erosion site.					
Inspector Comment					
Repair slope damage caused by large fallen tree.

View of a fallen tree and slope damage. Fall 2018

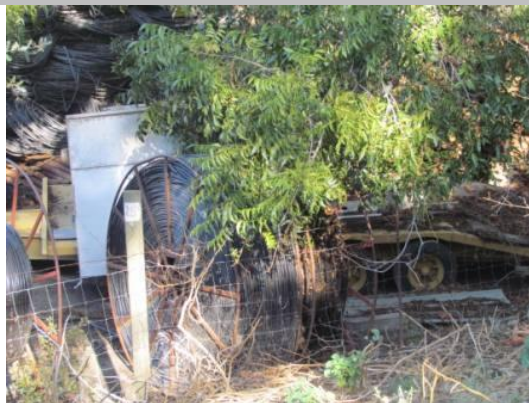
Photo 1 of 2 : SP\_2019\_RD0999\_236\_16\_20190307\_00012.jpg

LM Start	3.64	Rating **	M	Issue No.	16
LM End	3.64	Issue Type +	En	Location *	LS
Category	Earthen Levee			GPS Latitude/Longitude	
				Start	End
Item	Encroachments			38.366958 °	38.366958 °
				-121.556822 °	-121.556822 °
DWR ID	DWR_RD0999_05_s_2012_16				
Comment Code					
EQ : Equipment					
Inspector Comment					
Landowner needs to move equipment stored at landside toe easement; listed on levee log.

Looking northwest at equipment on landside toe.

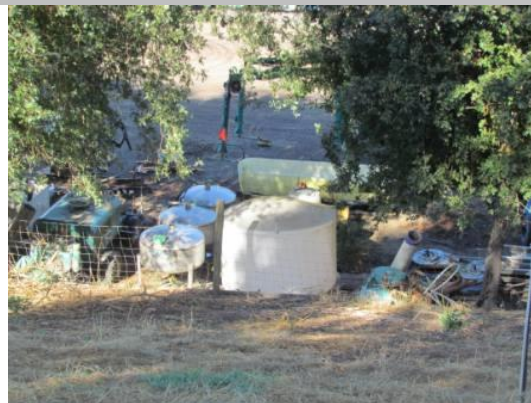
Photo 2 of 2 : SP\_2019\_RD0999\_236\_16\_20190307\_00013.jpg

LM Start	3.64	Rating **	M	Issue No.	16 (cont)	
LM End	3.64	Issue Type +	En	Location *	LS	
Category	Earthen Levee			GPS Latitude/Longitude		
				Start	End	
Item	Encroachments			38.366958 °	38.366958 °	
				-121.556822 °	-121.556822 °	
DWR ID	DWR_RD0999_05_s_2012_16					
Comment Code						
EQ : Equipment						
Inspector Comment						
Landowner needs to move equipment stored at landside toe easement; listed on levee log.

Looking west at equipment at landside toe.

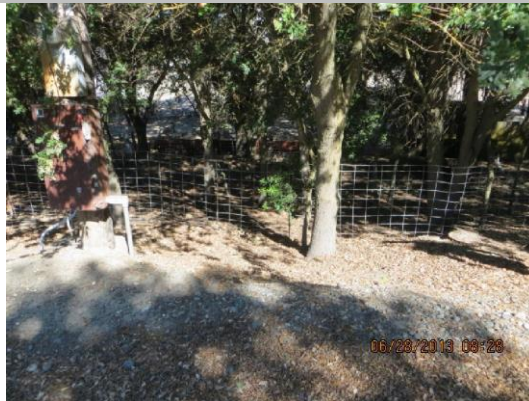
Photo 2 of 3 : UCIP\_SP\_2019\_16337\_27534.jpg

1.5-inch galvanized iron electrical conduit at same location.

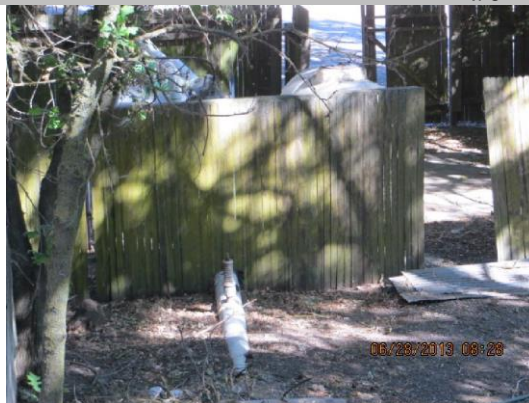
Photo 3 of 3 : UCIP\_SP\_2019\_16337\_27533.jpg

LM Start	3.67	Rating **	M	Issue No.	235 (cont)	
LM End	3.67	Issue Type +	En	Location *		
Category	Supplemental			GPS Latitude/Longitude		
				Start	End	
Item	DWR UCIP Field Study			38.367469 °	38.367469 °	
				-121.556509 °	-121.556509 °	
DWR ID	23965					
Comment Code						
Inspector Comment						
FS_ID:16337						
DS_ID:23965						
EP_NO: N/A						
Repair Type: Non-Urgent						
Crossing Status: Found						
UCIP Comments: Need to determine permit No. for this crossing.						
FIELD_STRUCT_DESC: 9-inch steel irrigation pipe through the levee, 2 feet below the crown. Pump on pier on the waterside (WS) with butterfly valve. Filter plant and siphon breaker on the landside (LS) toe. 1.5-inch galvanized iron electrical conduit at the same location.						
FS Date: 6/28/2013

Siphon breaker and filter plant on LS toe.

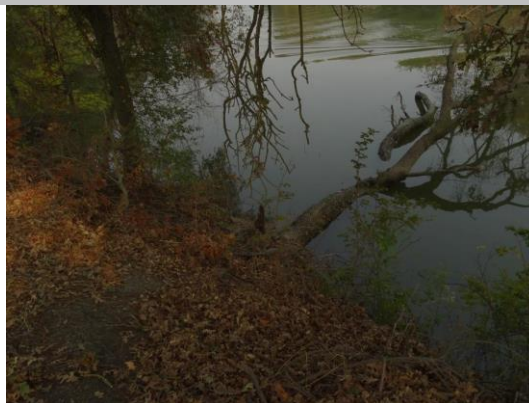
Photo 1 of 1 : SP\_2019\_RD0999\_236\_91\_20190307\_00037.jpg

LM Start	4.08	Rating **	M	Issue No.	91
LM End	4.08	Issue Type +	Ma	Location *	WS
Category	Earthen Levee			GPS Latitude/Longitude	
				Start	End
Item	Erosion / Bank Caving			38.370853 °	38.370853 °
				-121.553605 °	-121.553605 °
DWR ID	DWR_RD0999_05_f_2018_91				
Comment Code					
E2 : Schedule repair of erosion site prior to the next inspection.					
Inspector Comment					
Repair erosion caused by fallen tree with exposed rootball.

View of tree with rootball exposed. Fall 2018

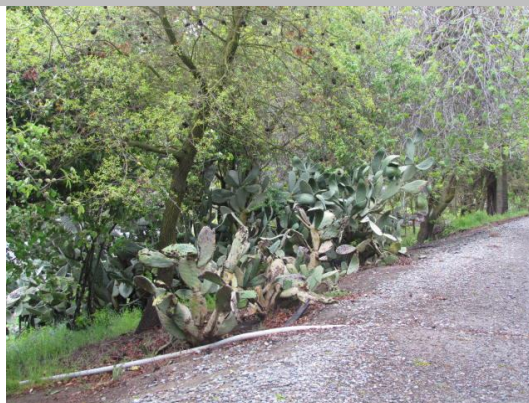
Photo 1 of 1 : SP\_2019\_RD0999\_236\_56\_20190307\_00024.jpg

LM Start	4.37	Rating **	M	Issue No.	56
LM End	4.37	Issue Type +	En	Location *	LS
Category	Earthen Levee			GPS Latitude/Longitude	
				Start	End
Item	Vegetation			38.374410 °	38.374410 °
				-121.551173 °	-121.551173 °
DWR ID	DWR_RD0999_05_s_2012_56				
Comment Code					
V6 : Landscaping					
Inspector Comment					
Instruct landowner to remove cactus from levee easement.

Looking northwest at cactus on landside shoulder and slope. (Spring 2012)

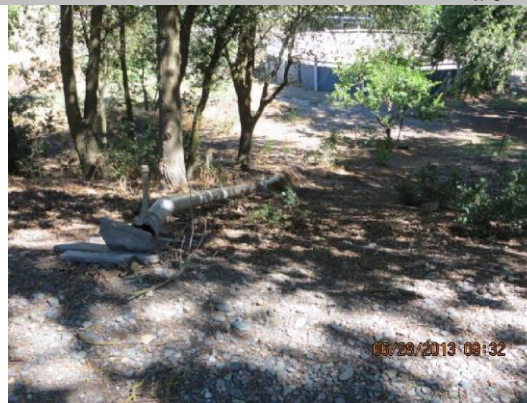
Photo 1 of 3 : UCIP\_SP\_2019\_16403\_27686.jpg

LM Start	4.45	Rating **	M	Issue No.	237
LM End	4.45	Issue Type +	En	Location *	
Category	Supplemental			GPS Latitude/Longitude	
				Start	End
Item	DWR UCIP Field Study			38.375036 °	38.375036 °
				-121.549961 °	-121.549961 °
DWR ID	23967				
Comment Code					
Inspector Comment					
FS_ID:16403 DS_ID:23967 EP_NO: N/A Repair Type: Non-Urgent Crossing Status: Found UCIP Comments: Need to determine Permit No. for this crossing or remove it. FIELD_STRUCT_DESC: 5-inch temporary aluminum irrigation pipe over the top of the levee. Portable pump on the waterside (WS) toe. FS Date: 6/28/2013

Pipe on LS slope.

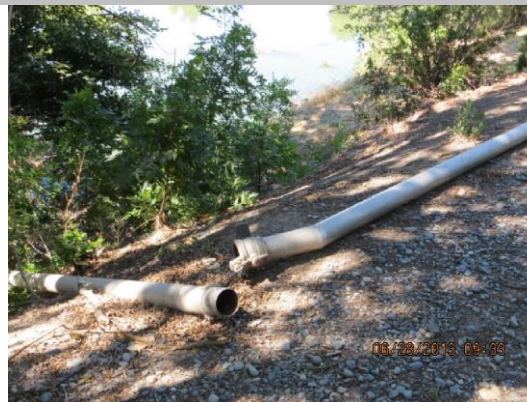
Photo 2 of 3 : UCIP\_SP\_2019\_16403\_27685.jpg

Pipe on WS slope.

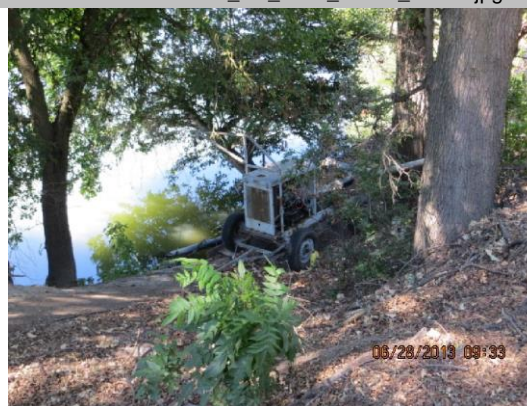
Photo 3 of 3 : UCIP\_SP\_2019\_16403\_27687.jpg

LM Start	4.45	Rating **	M	Issue No.	237 (cont)	
LM End	4.45	Issue Type +	En	Location *		
Category	Supplemental			GPS Latitude/Longitude		
				Start	End	
Item	DWR UCIP Field Study			38.375036 °	38.375036 °	
				-121.549961 °	-121.549961 °	
DWR ID	23967					
Comment Code						
Inspector Comment						
FS_ID:16403 DS_ID:23967 EP_NO: N/A Repair Type: Non-Urgent Crossing Status: Found UCIP Comments: Need to determine Permit No. for this crossing or remove it. FIELD_STRUCT_DESC: 5-inch temporary aluminum irrigation pipe over the top of the levee. Portable pump on the waterside (WS) toe. FS Date: 6/28/2013

Portable pump on WS toe.

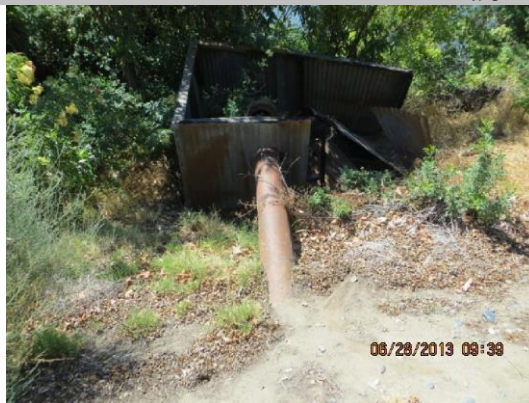
Photo 1 of 3 : UCIP\_SP\_2019\_15443\_25362.jpg

Comment Code					
Inspector Comment					
FS_ID:15443 DS_ID:22882 EP_NO: 7383 Repair Type: Non-Urgent Crossing Status: Found UCIP Comments: Pipe abandoned and should be done so properly. FIELD_STRUCT_DESC: 10-inch steel irrigation pipe through the levee, 4 feet below the crown. Pump house on the waterside (WS) slope, and a joint pole (JP) on the landside (LS) shoulder. 1.5-inch galvanized iron electrical conduit at the same location. Replaces an existing portion of a 10-inch pipe within the levee section. (Permit No. 7383, 1971 - Monticello Vineyards). [Additional Reference(s): USACE Sacramento O&M Manual 113 (Revised), October 1966, (HLM 4.84)]. FS Date: 6/28/2013

Abandoned pumphouse on WS slope.

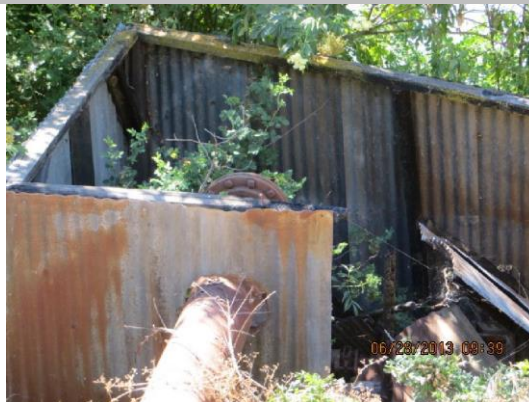
Photo 2 of 3 : UCIP\_SP\_2019\_15443\_25361.jpg

Abandoned pumphouse on WS slope.

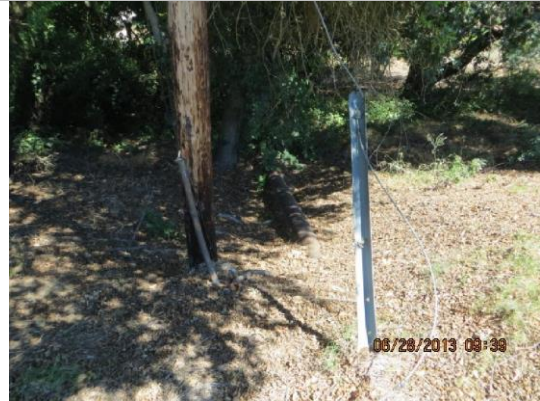
Photo 3 of 3 : UCIP\_SP\_2019\_15443\_25360.jpg

Comment Code						
Inspector Comment						
FS_ID:15443 DS_ID:22882 EP_NO: 7383 Repair Type: Non-Urgent Crossing Status: Found UCIP Comments: Pipe abandoned and should be done so properly. FIELD_STRUCT_DESC: 10-inch steel irrigation pipe through the levee, 4 feet below the crown. Pump house on the waterside (WS) slope, and a joint pole (JP) on the landside (LS) shoulder. 1.5-inch galvanized iron electrical conduit at the same location. Replaces an existing portion of a 10-inch pipe within the levee section. (Permit No. 7383, 1971 - Monticello Vineyards). [Additional Reference(s): USACE Sacramento O&M Manual 113 (Revised), October 1966, (HLM 4.84)]. FS Date: 6/28/2013

Pipe visible on LS slope.
